# Huia Domain: Erosion Management Options

*Paul Klinac, Team Manager  
Coastal Management Services*

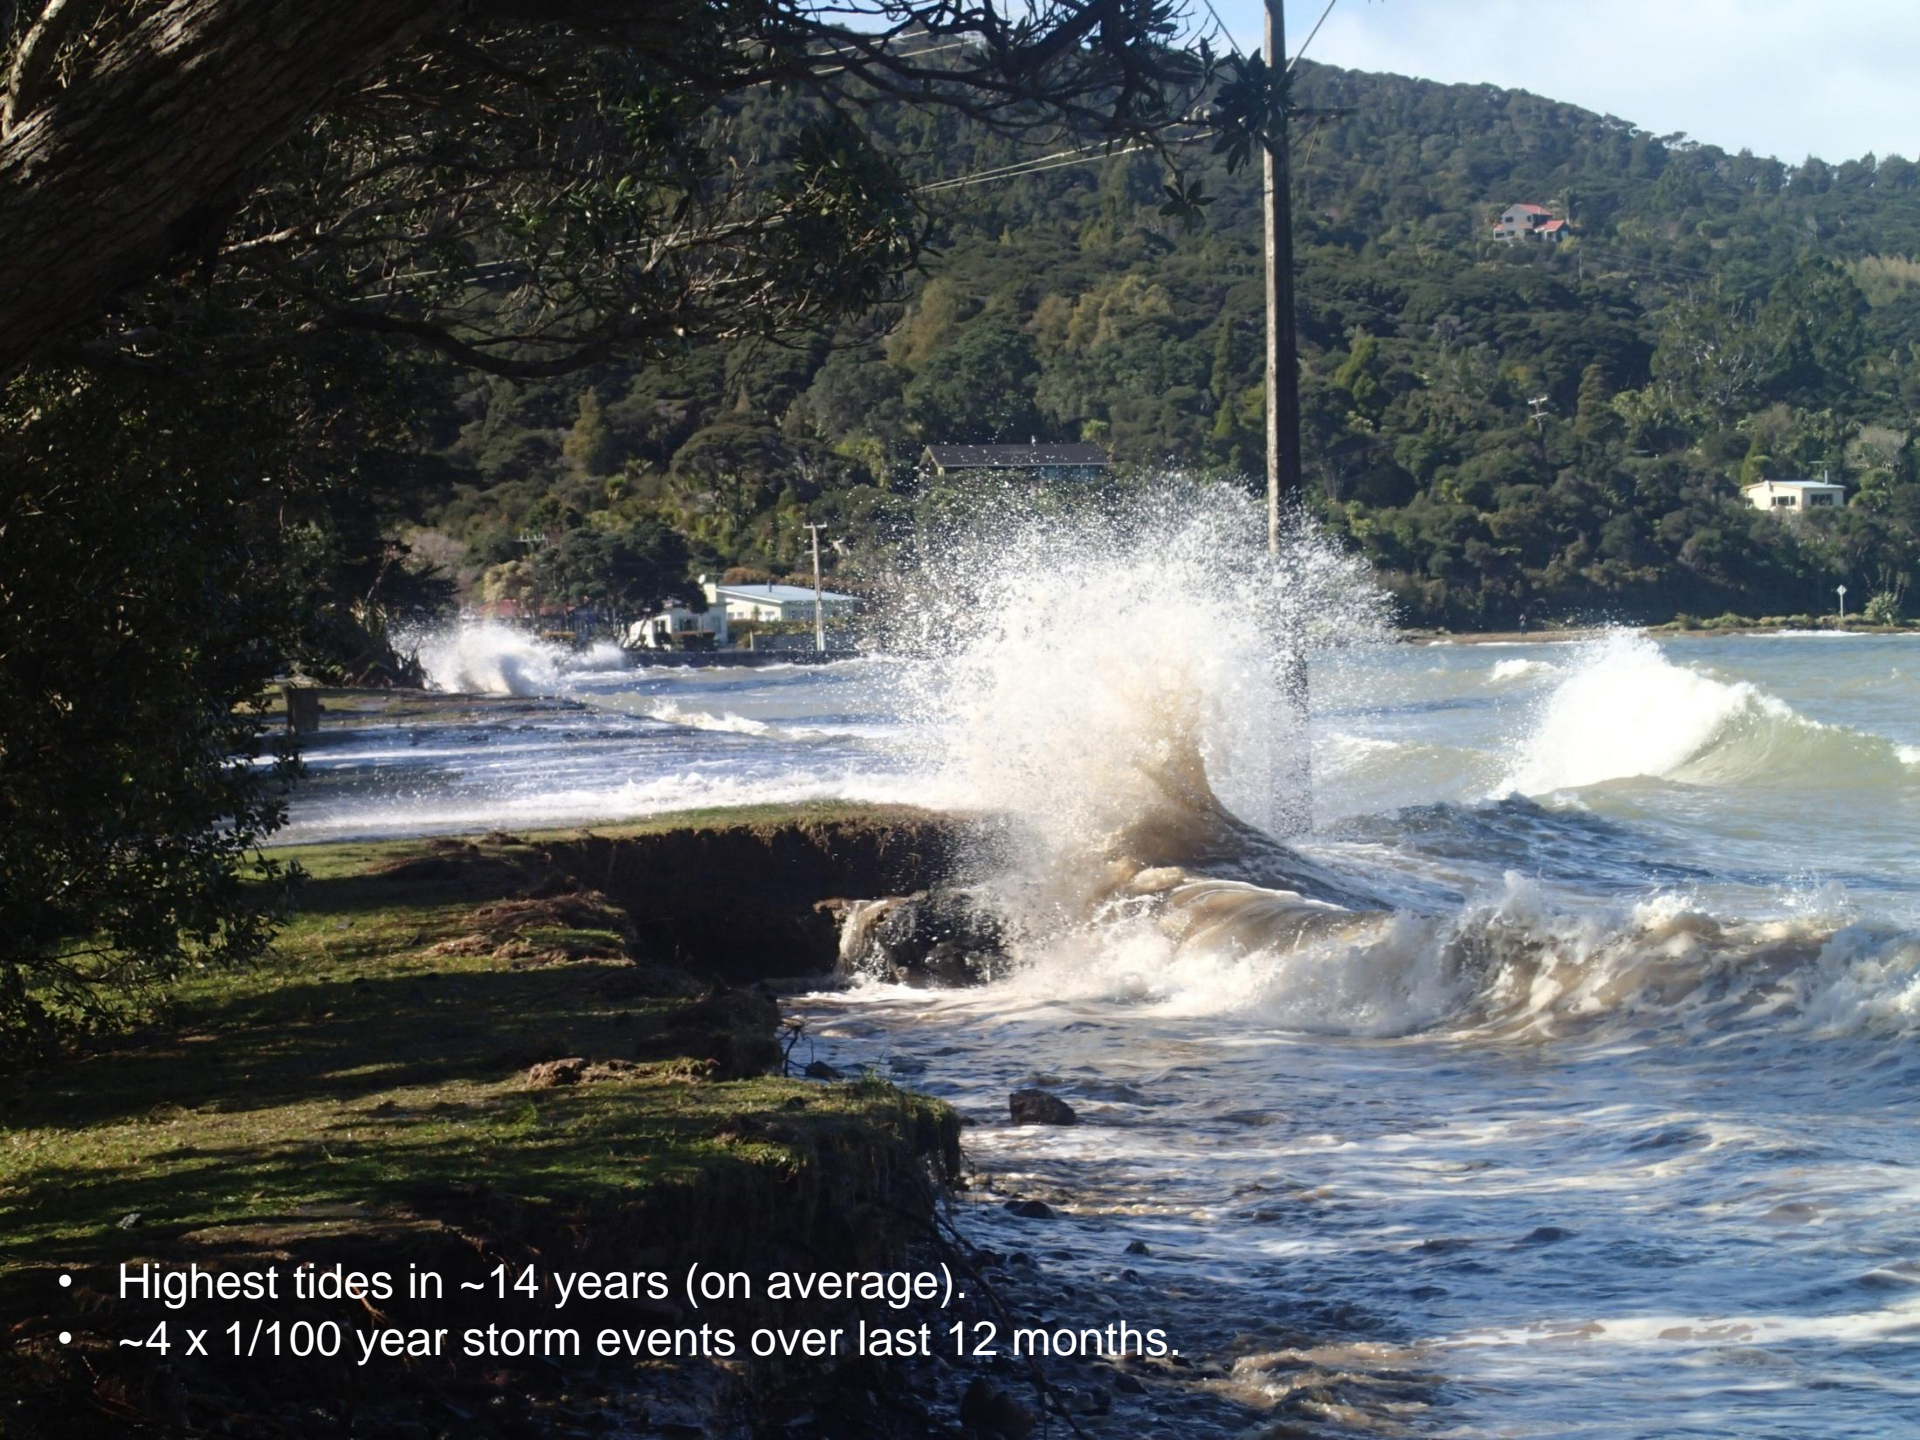
- Swell propagation and refraction into bay (during heavy SW swell)
- Above reinforced during extreme tides
- Combination of heavy swell and extreme tides results in erosion

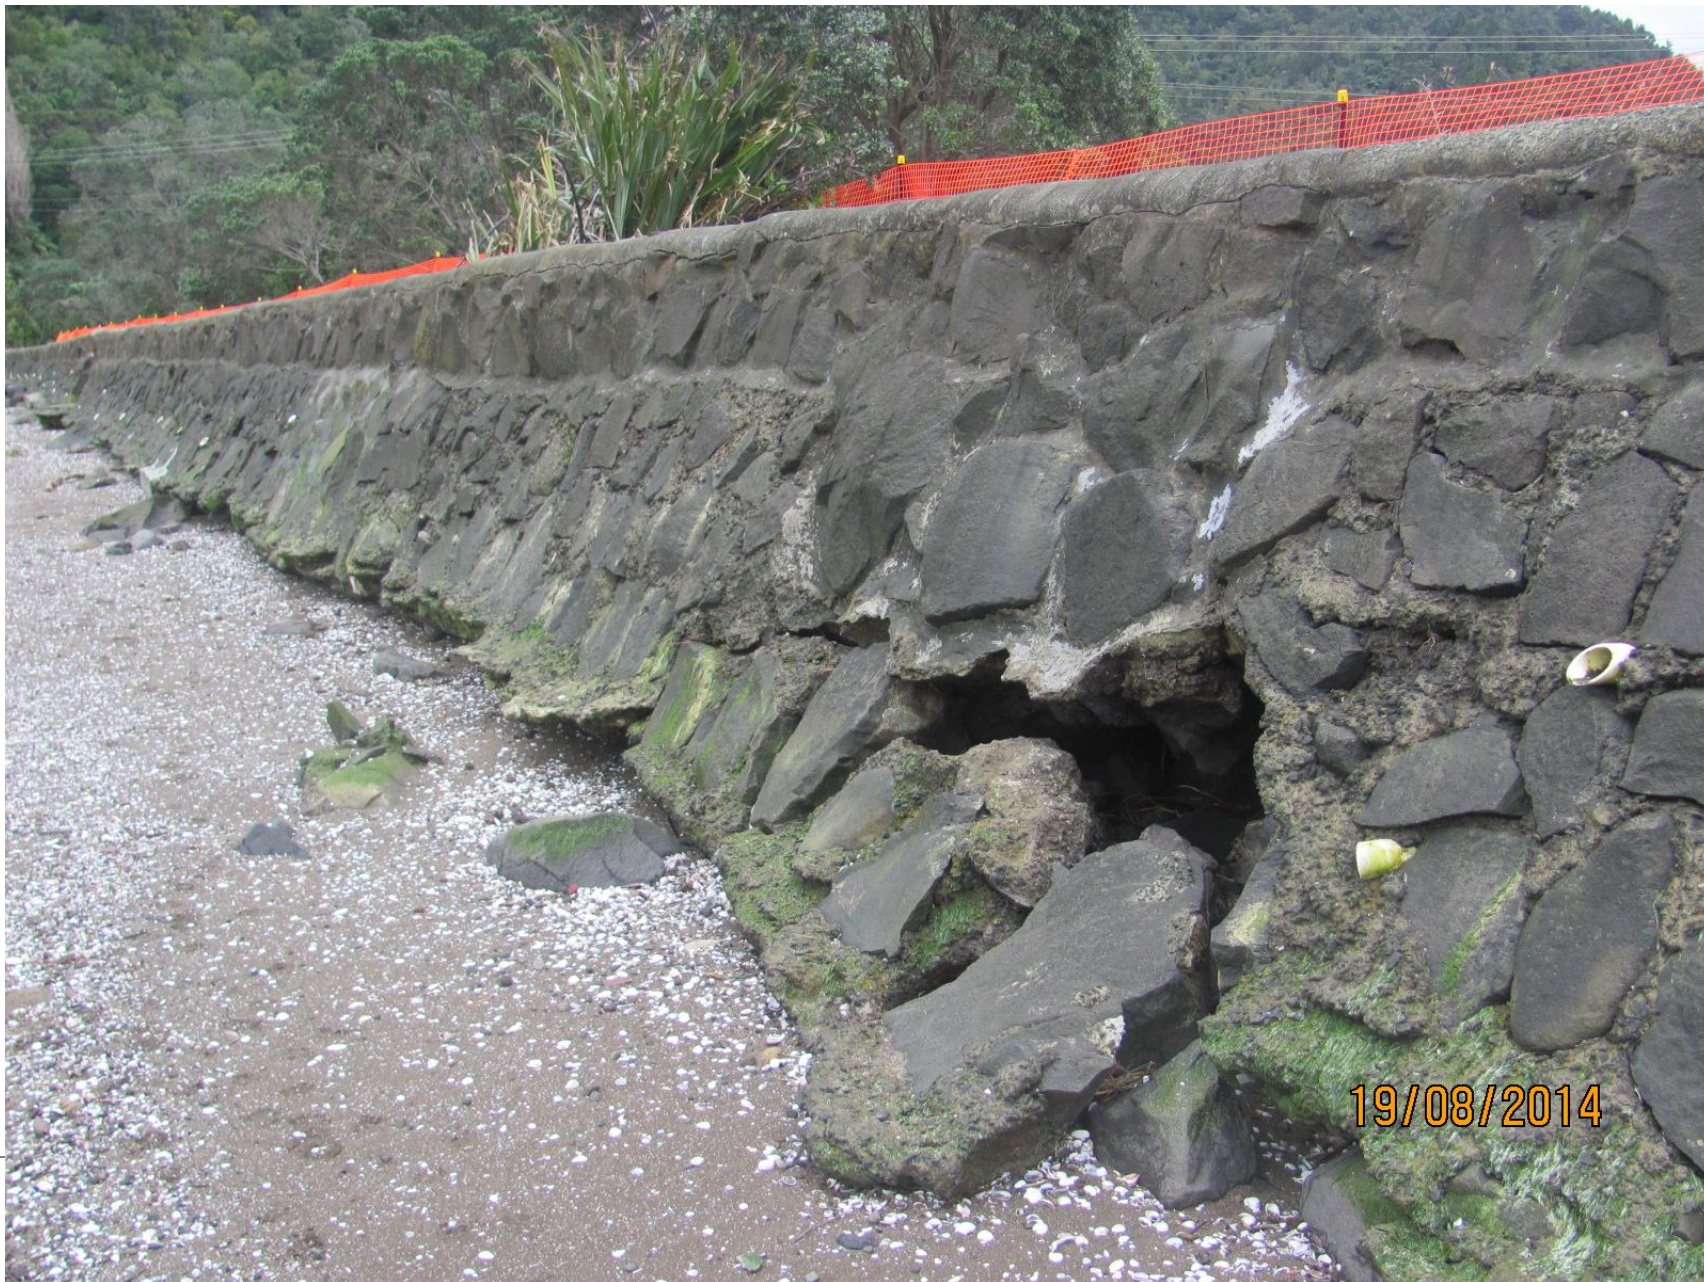
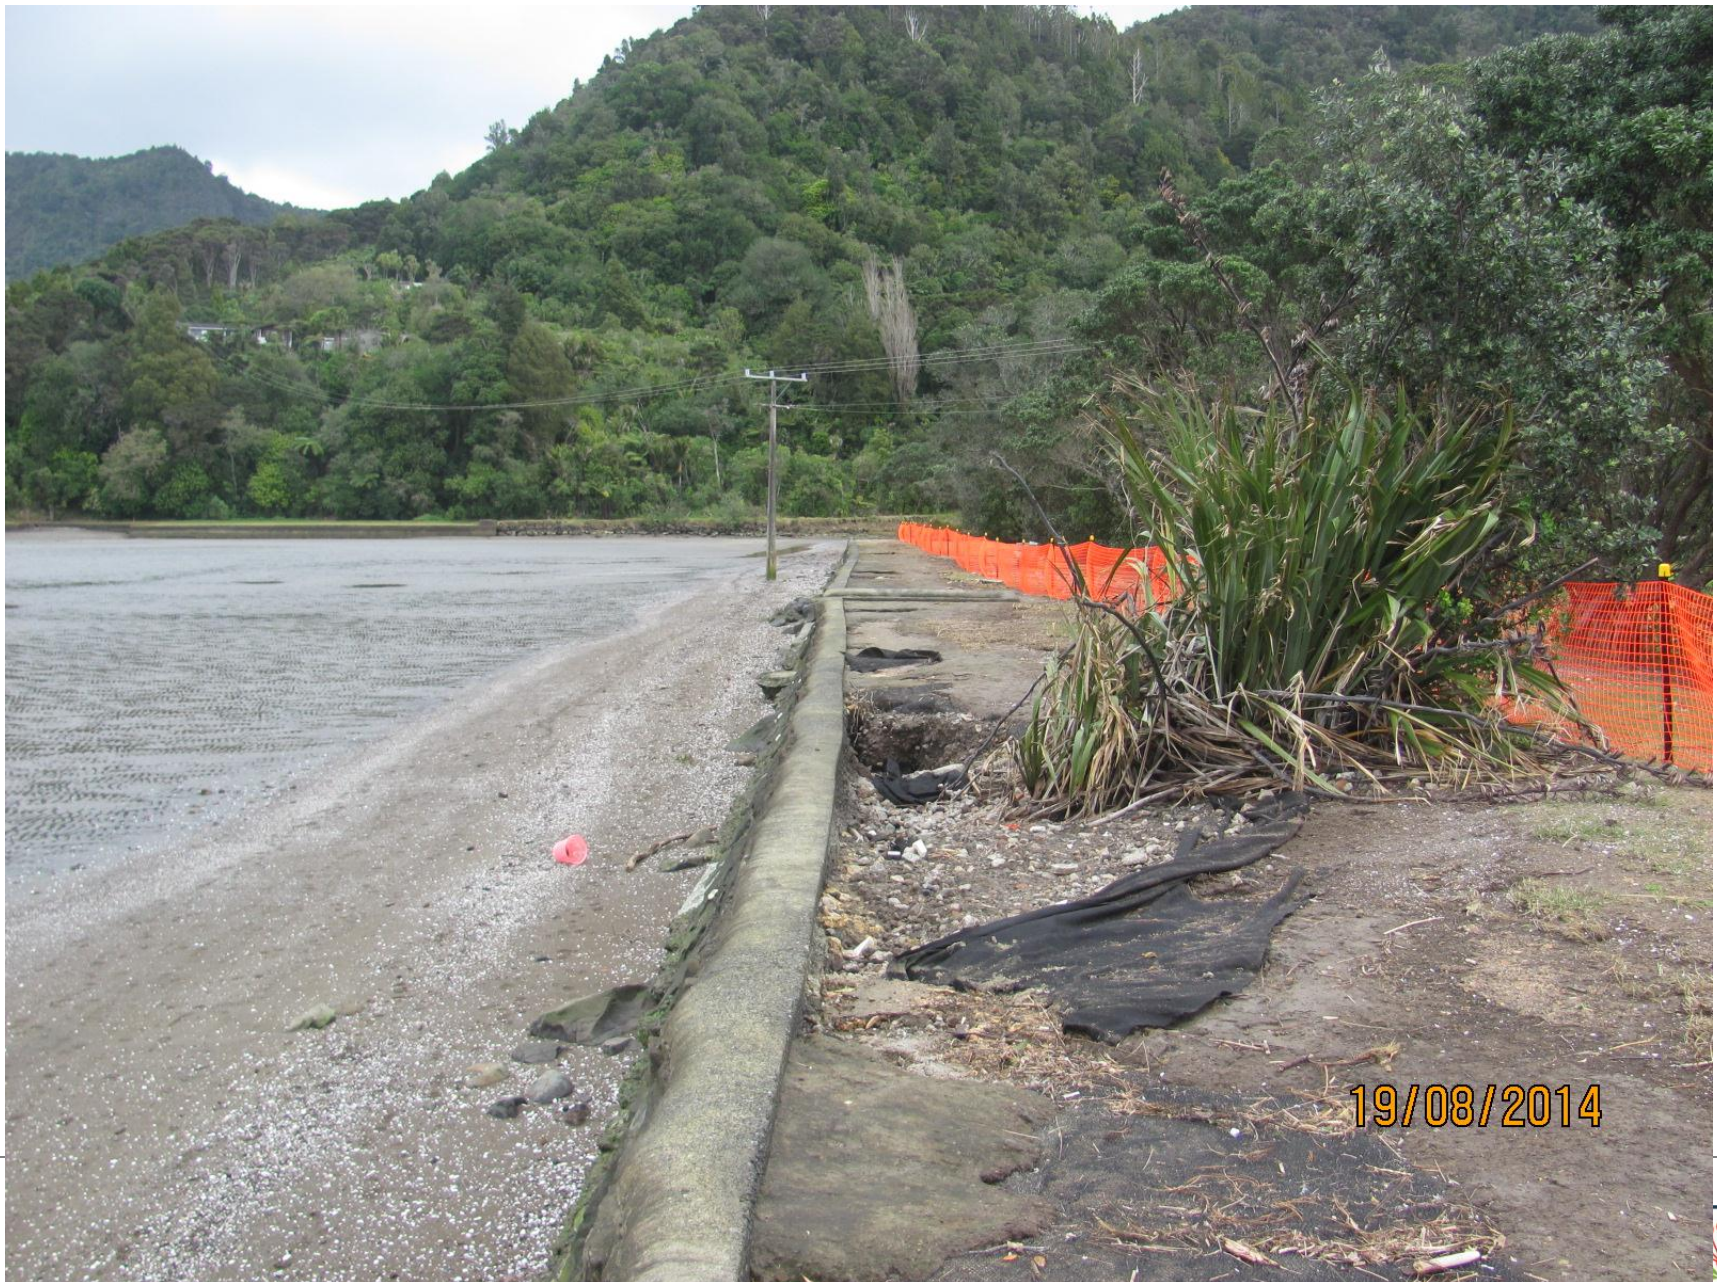
19/08/2014

- Highest tides in ~14 years (on average).
- ~4 x 1/100 year storm events over last 12 months.

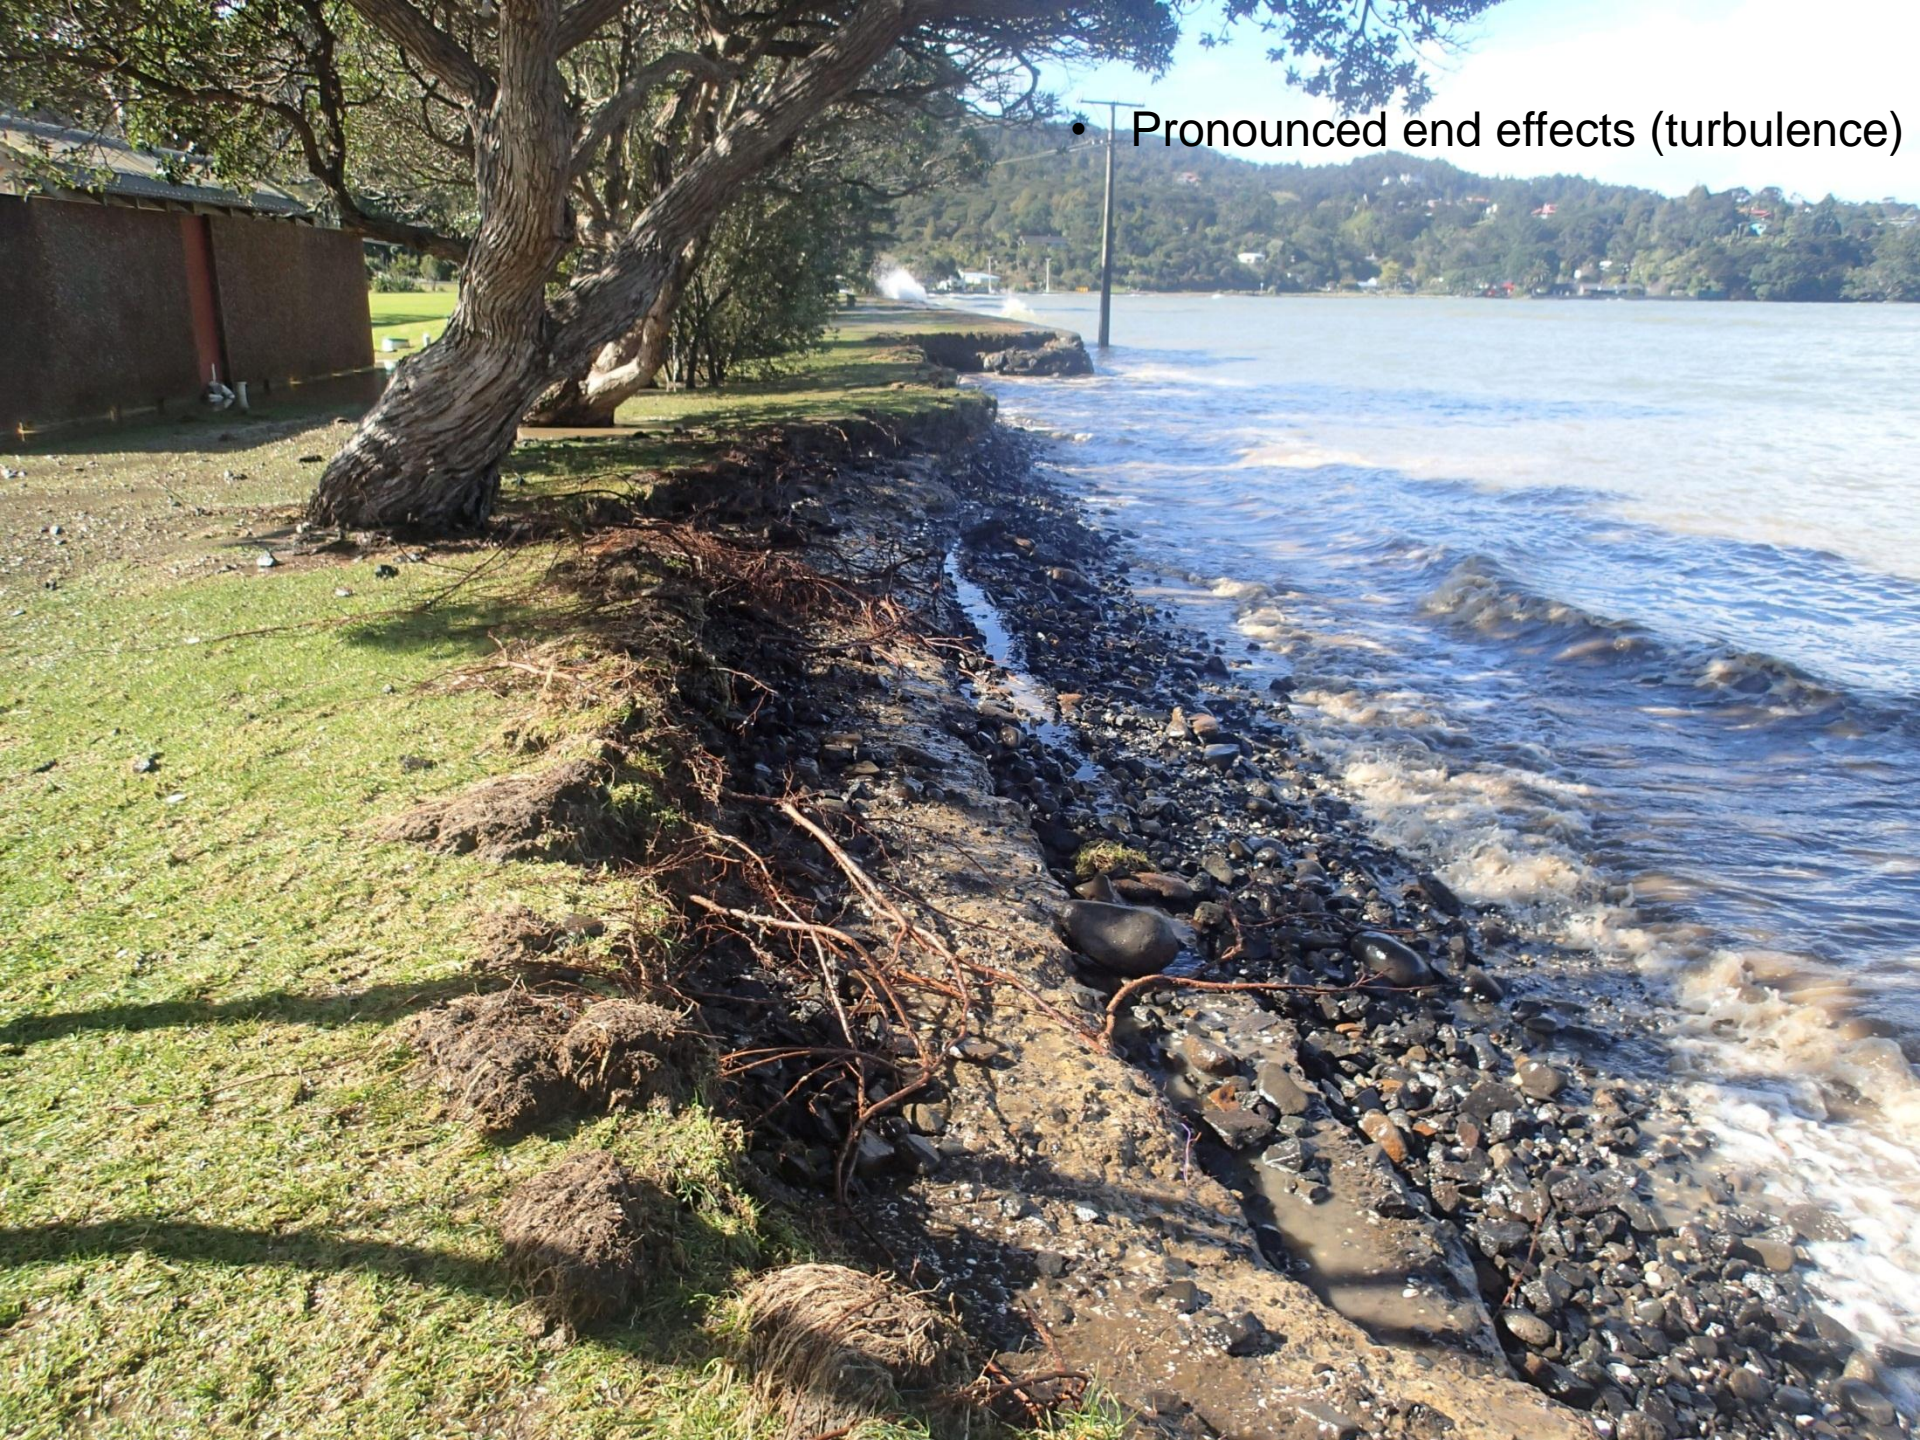
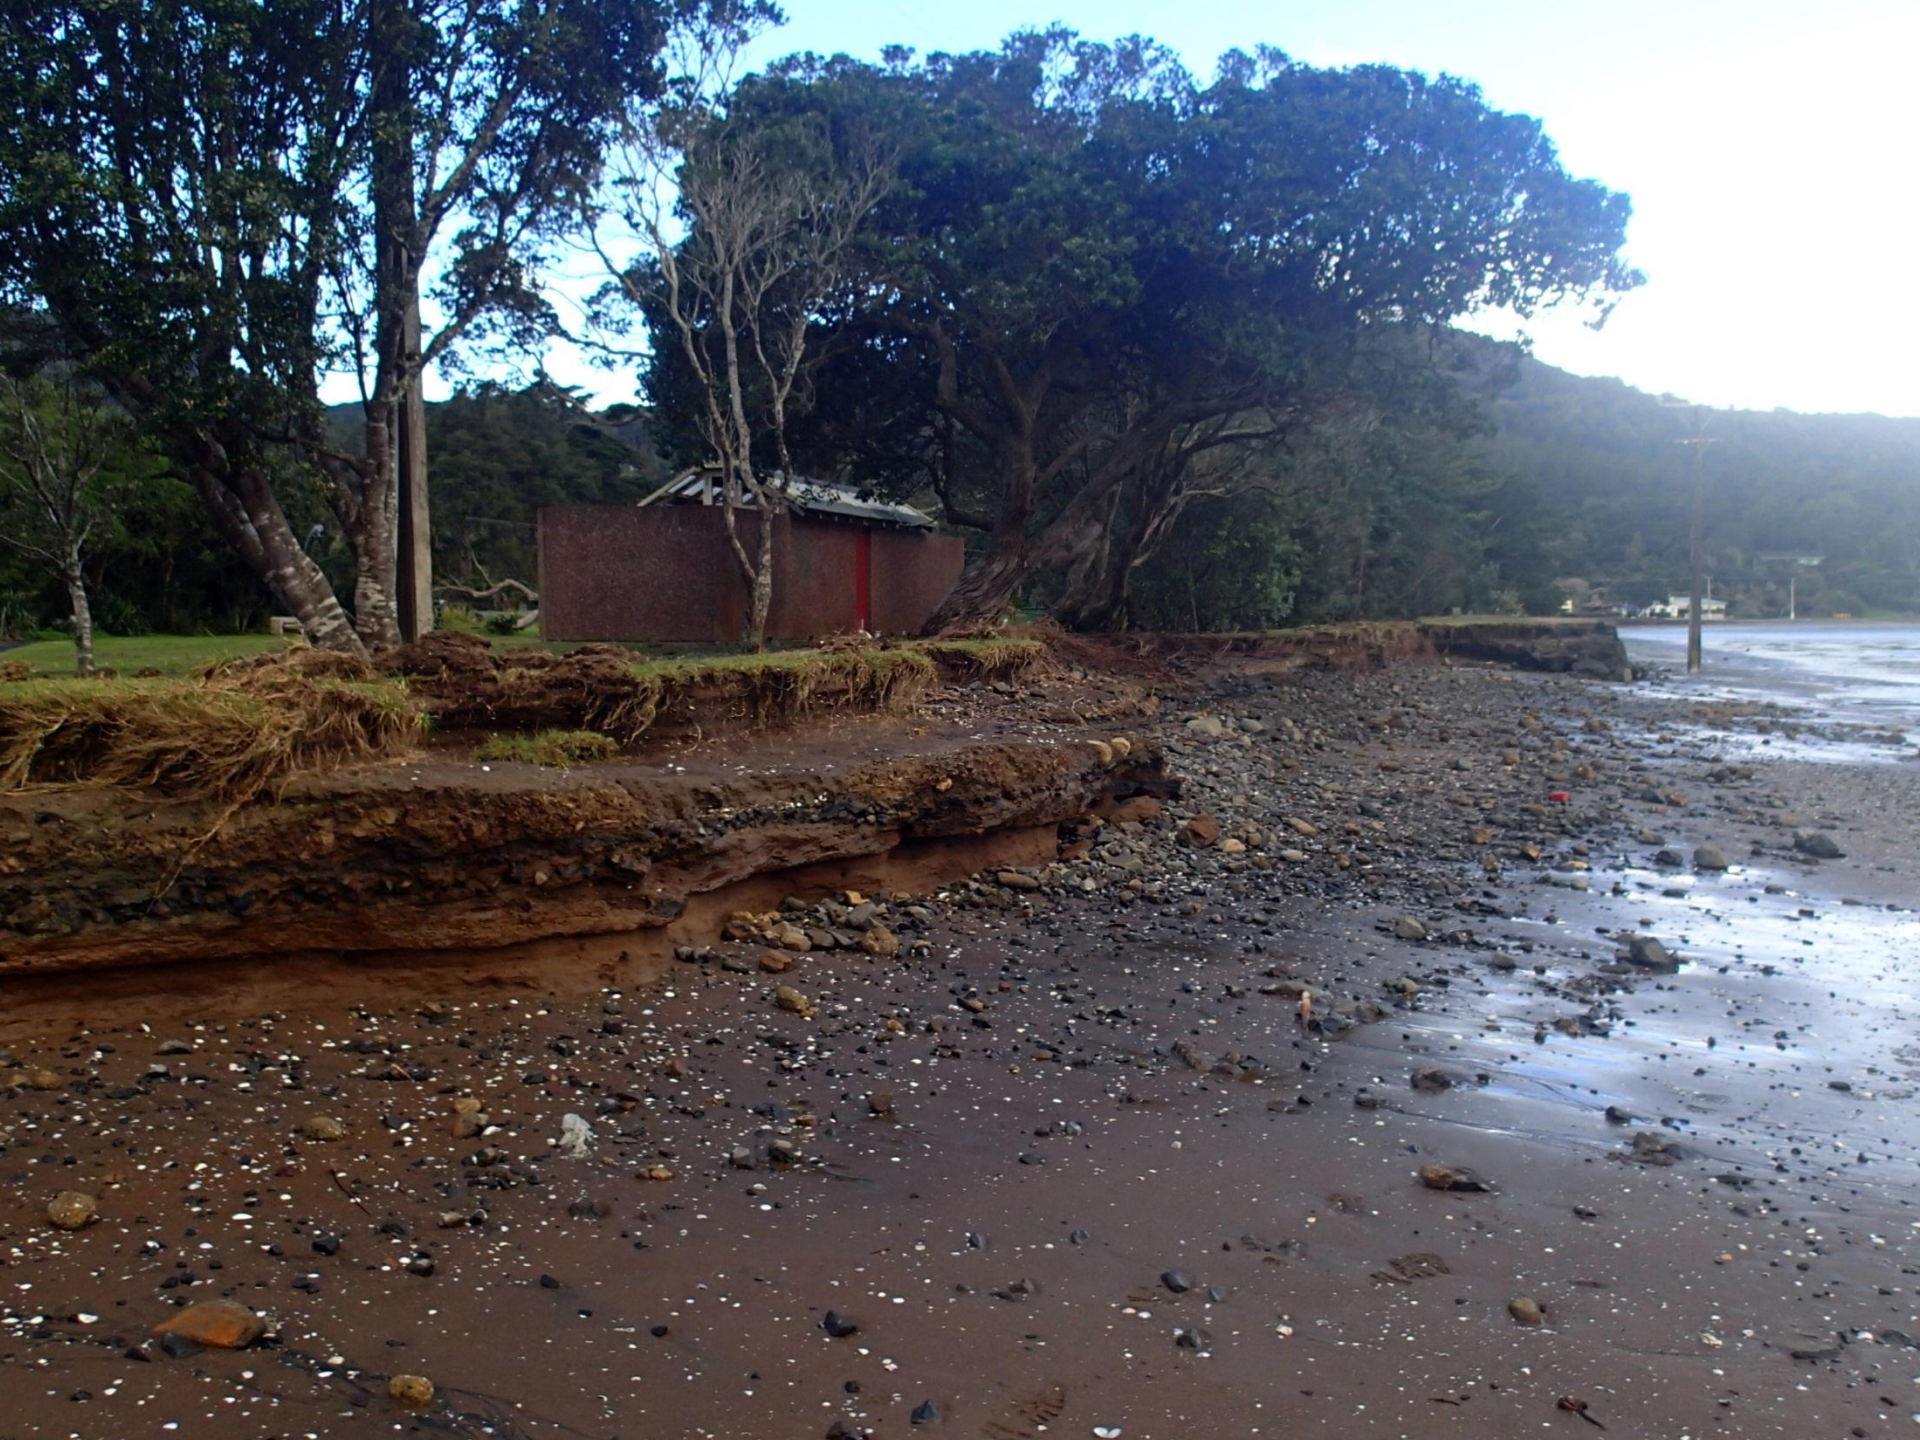
- Pronounced end effects (turbulence)
