# *Management Options:*

**HUIA BAY**  
Refined issues and options assessment  
Short term solution

**AUCKLAND COUNCIL**  
**HUIA DOMAIN MANAGED REALIGNMENT**

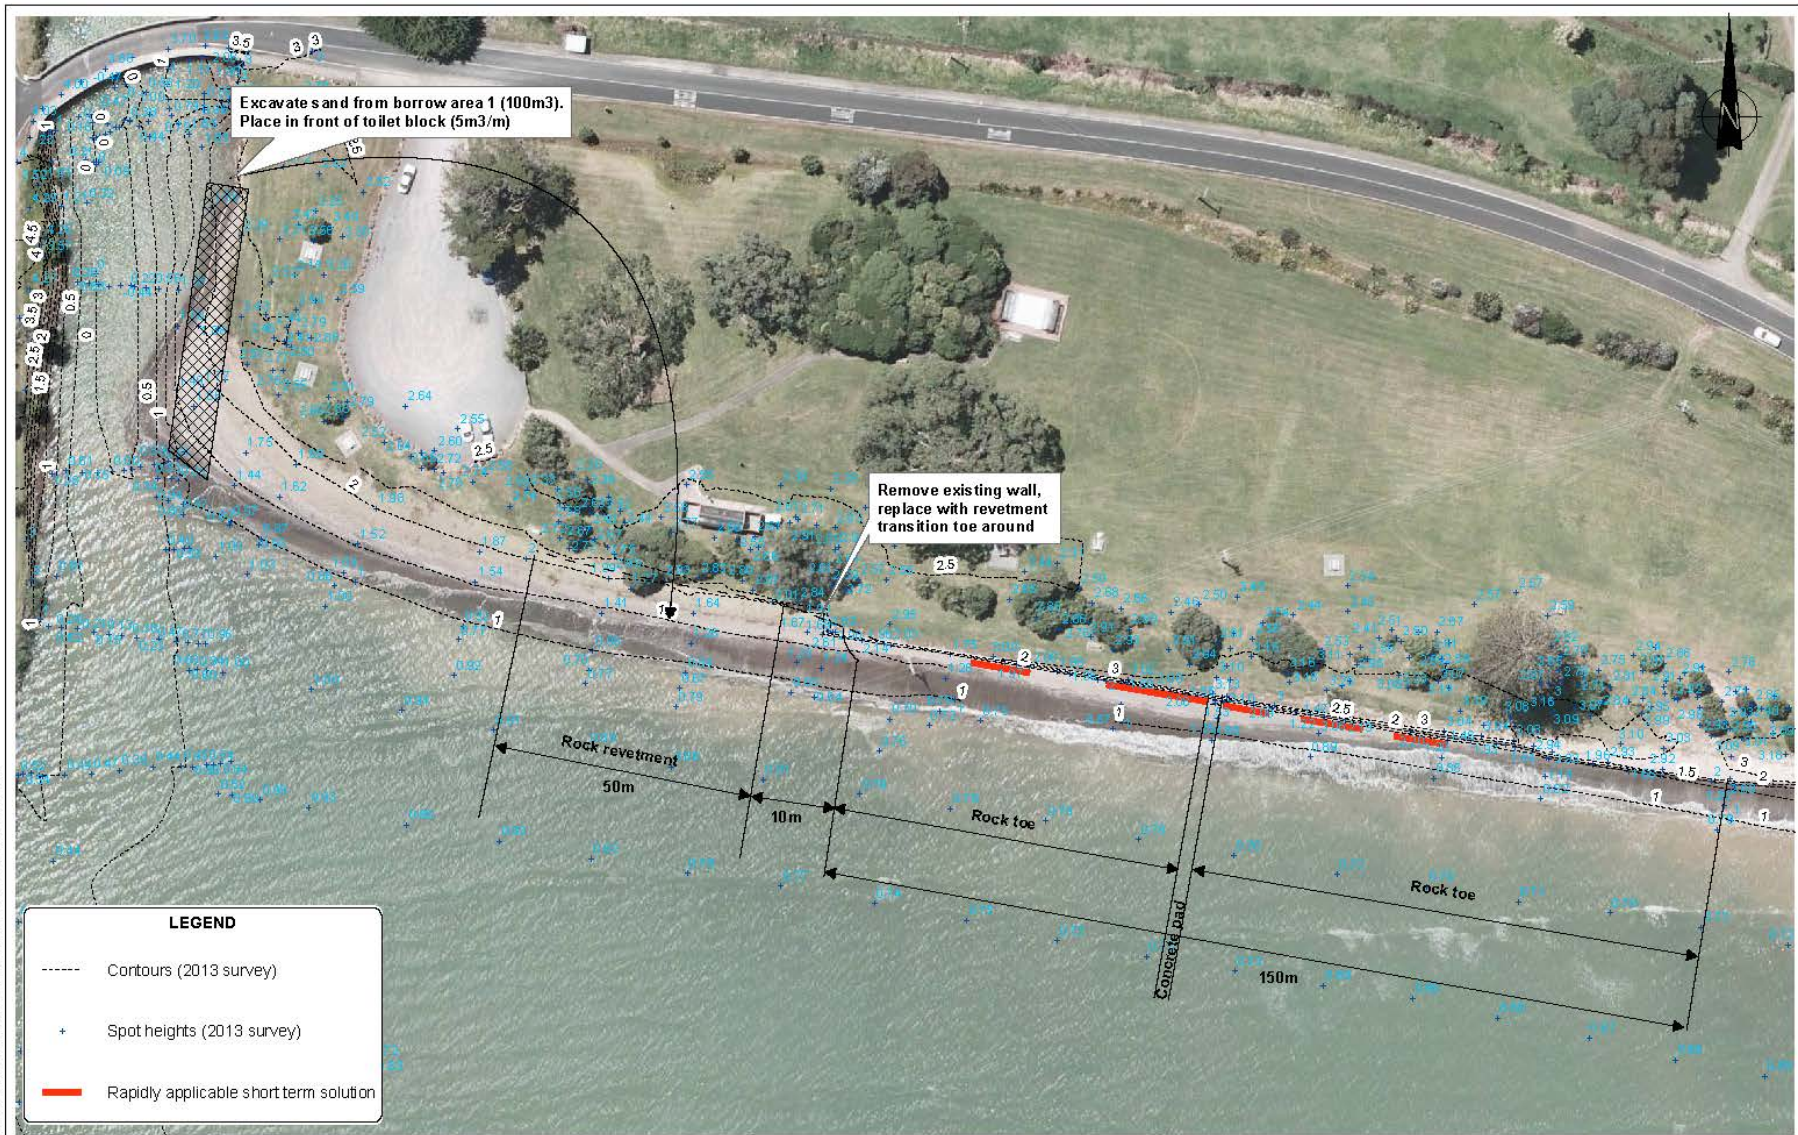
FIGURE NO. Figure B1

- Provision of rock riprap along the base of existing seawall.
- Western extension of seawall past toilet block (to provide limited protection).
- Provision of fill and improved drainage immediately landward (obviate scour during overtopping events).
- Targeted beach sand redistribution (from west to east) to provide buffer and improve amenity).

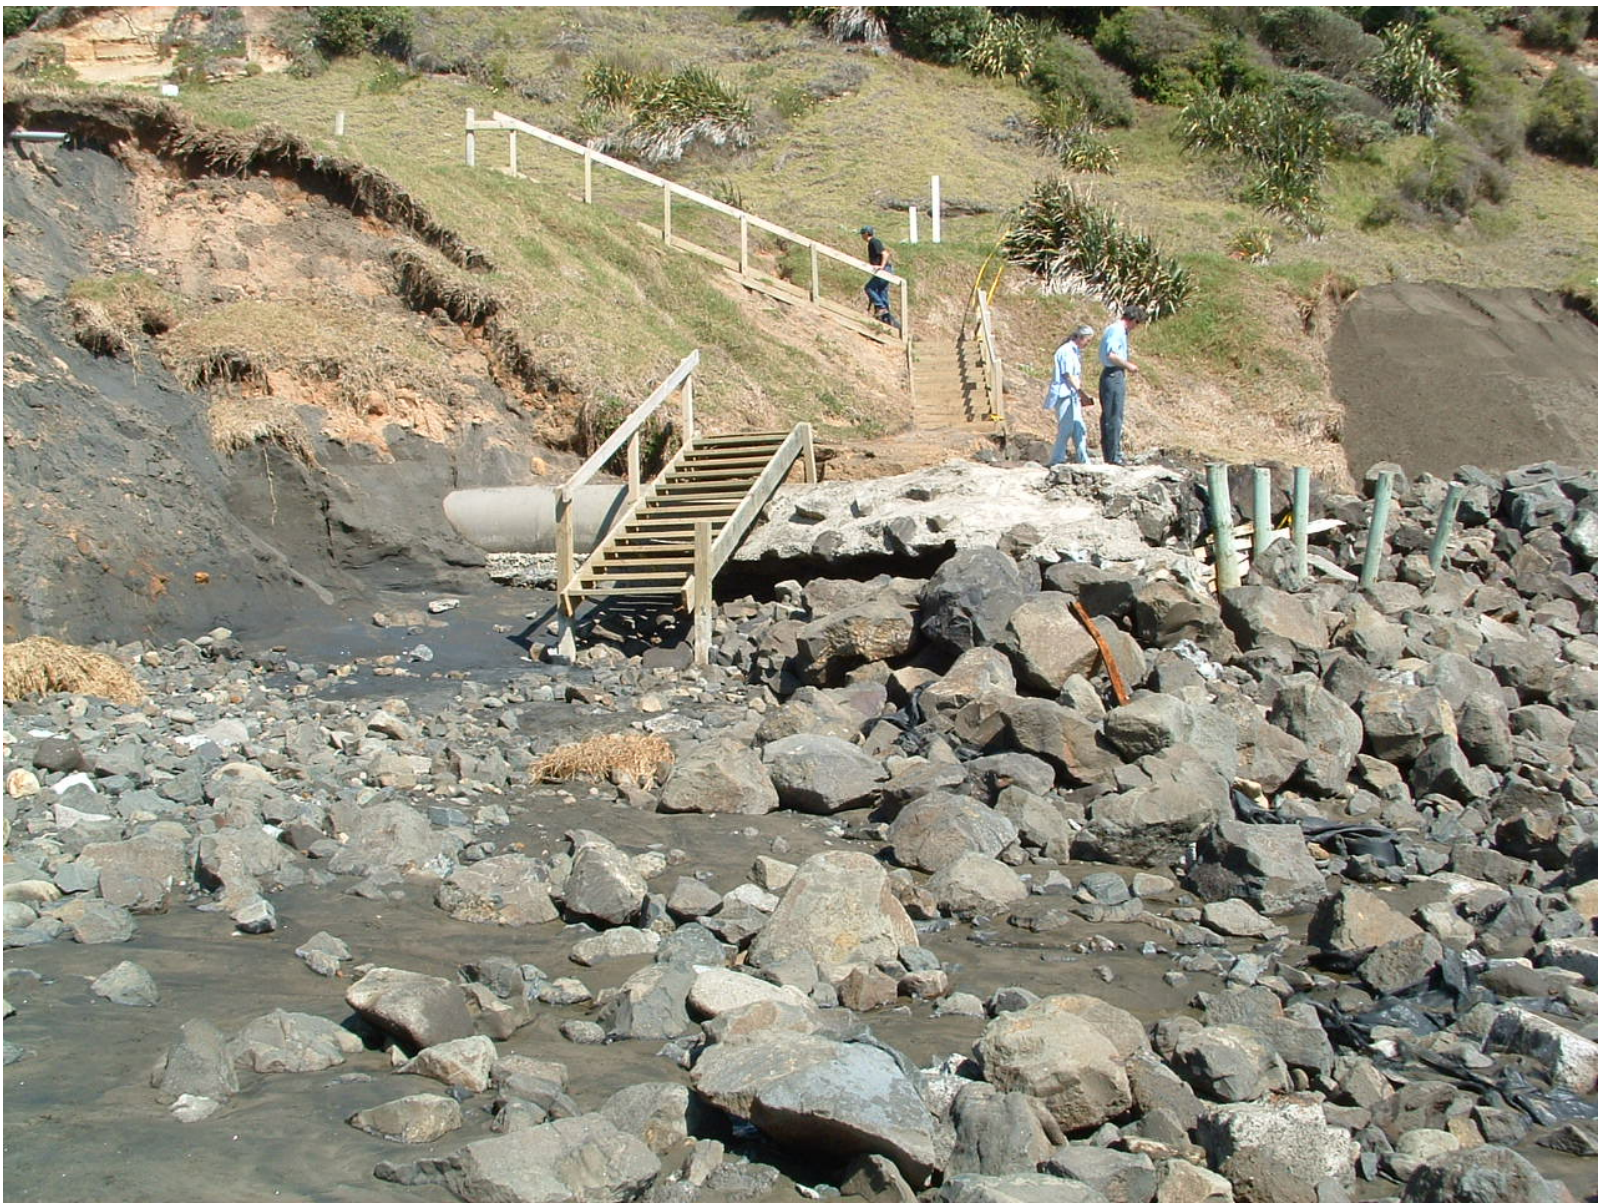
*Muriwai Beach (2005) Management Realignment (case study)*

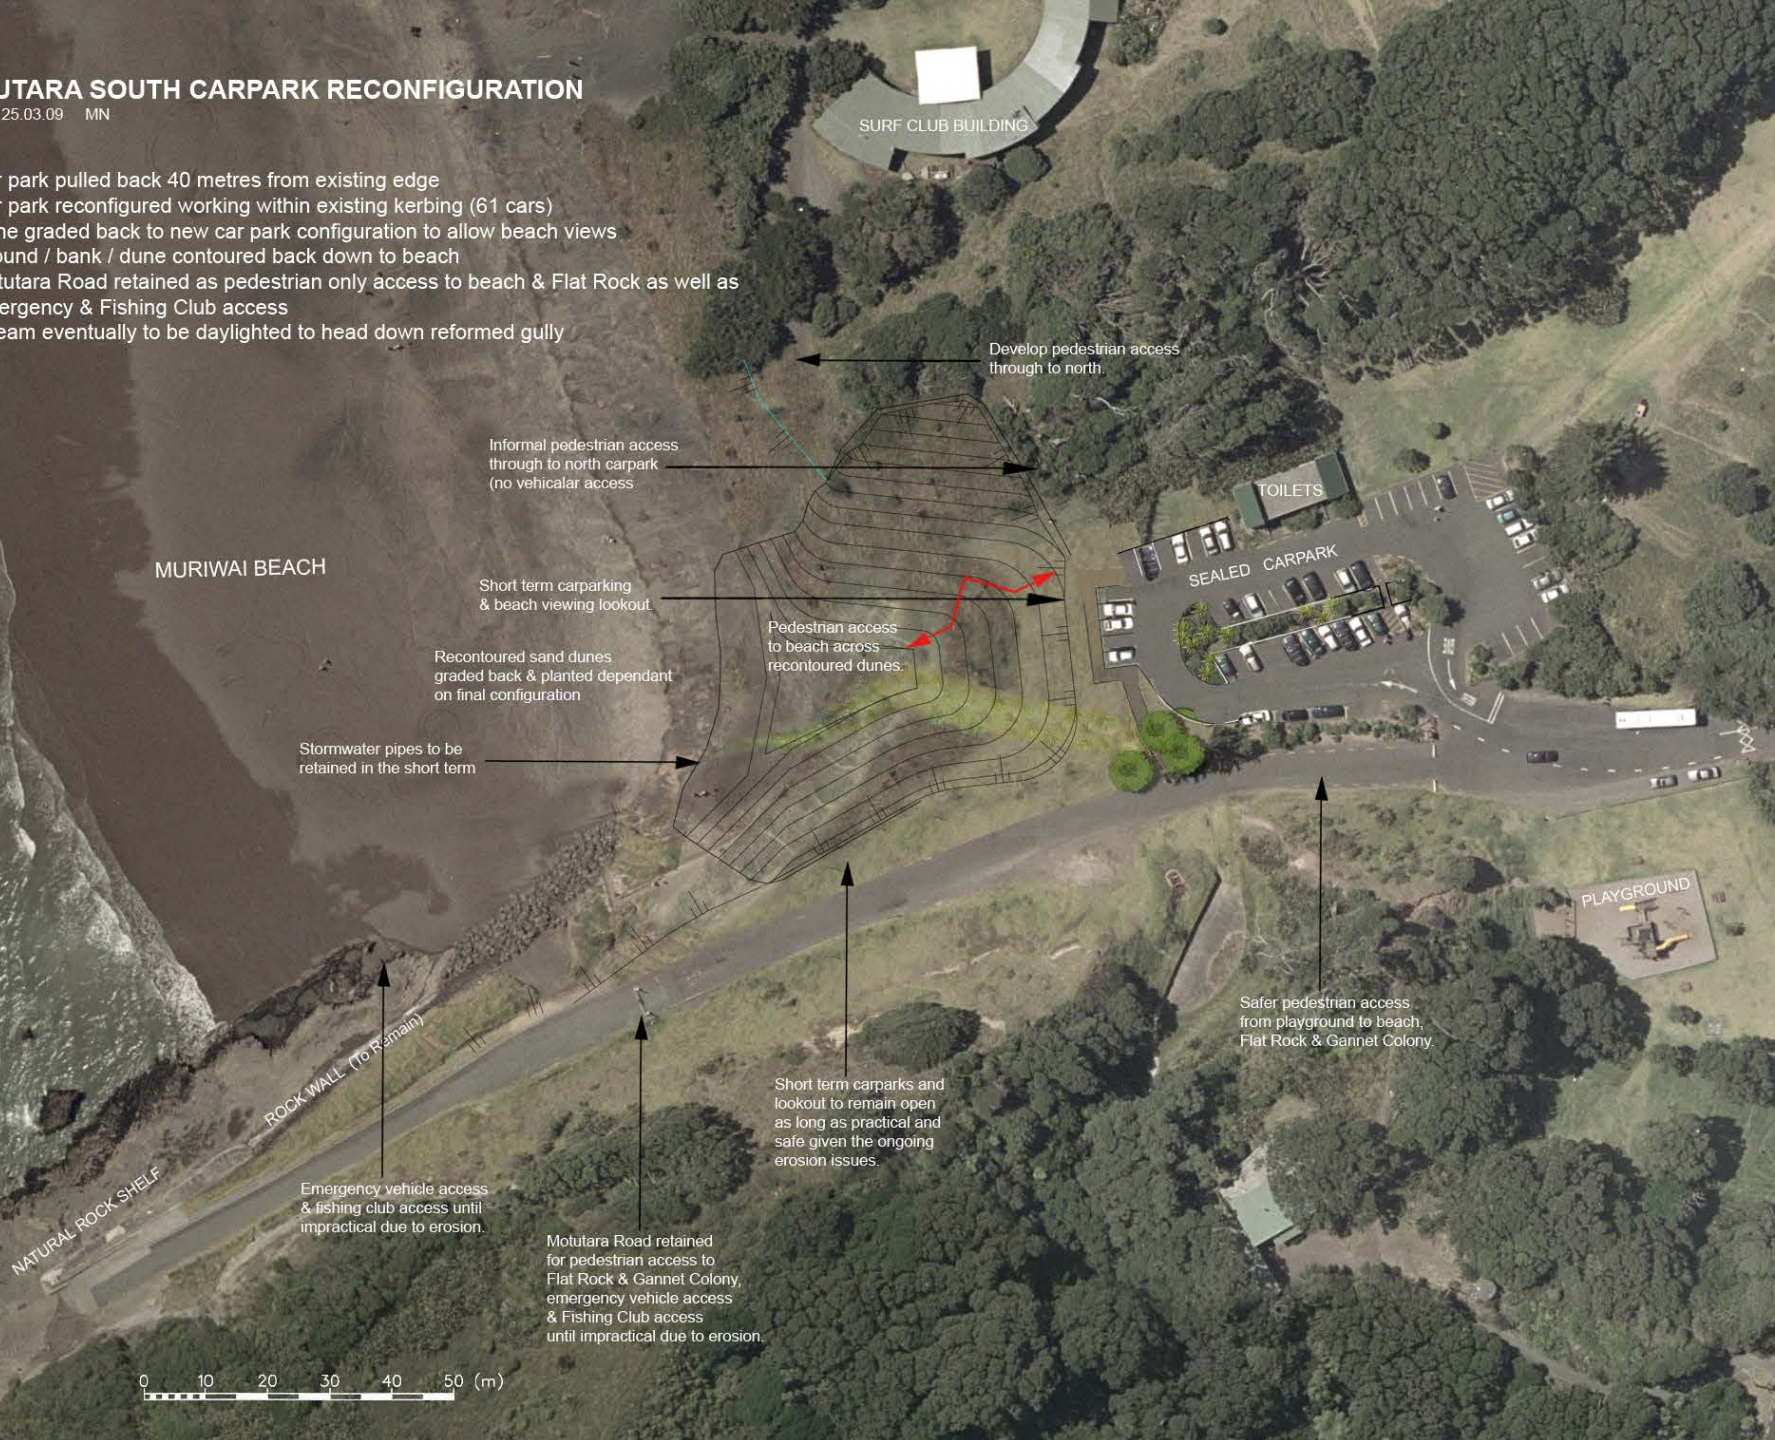
# MOTUTARA SOUTH CARPARK RECONFIGURATION

- Car park pulled back 40 metres from existing edge
- Car park reconfigured working within existing kerbing (61 cars)
- Dune graded back to new car park configuration to allow beach views
- Ground / bank / dune contoured back down to beach
- Motutara Road retained as pedestrian only access to beach & Flat Rock as well as emergency & Fishing Club access
- Stream eventually to be daylighted to head down reformed gully

Short term carparking & beach viewing lookout

Recontoured sand dunes graded back & planted dependant on final configuration

Stormwater pipes to be retained in the short term

Short term carparks and lookout to remain open as long as practical and safe given the ongoing erosion issues.

Motutara Road retained for pedestrian access to Flat Rock & Gannet Colony, emergency vehicle access & Fishing Club access until impractical due to erosion.

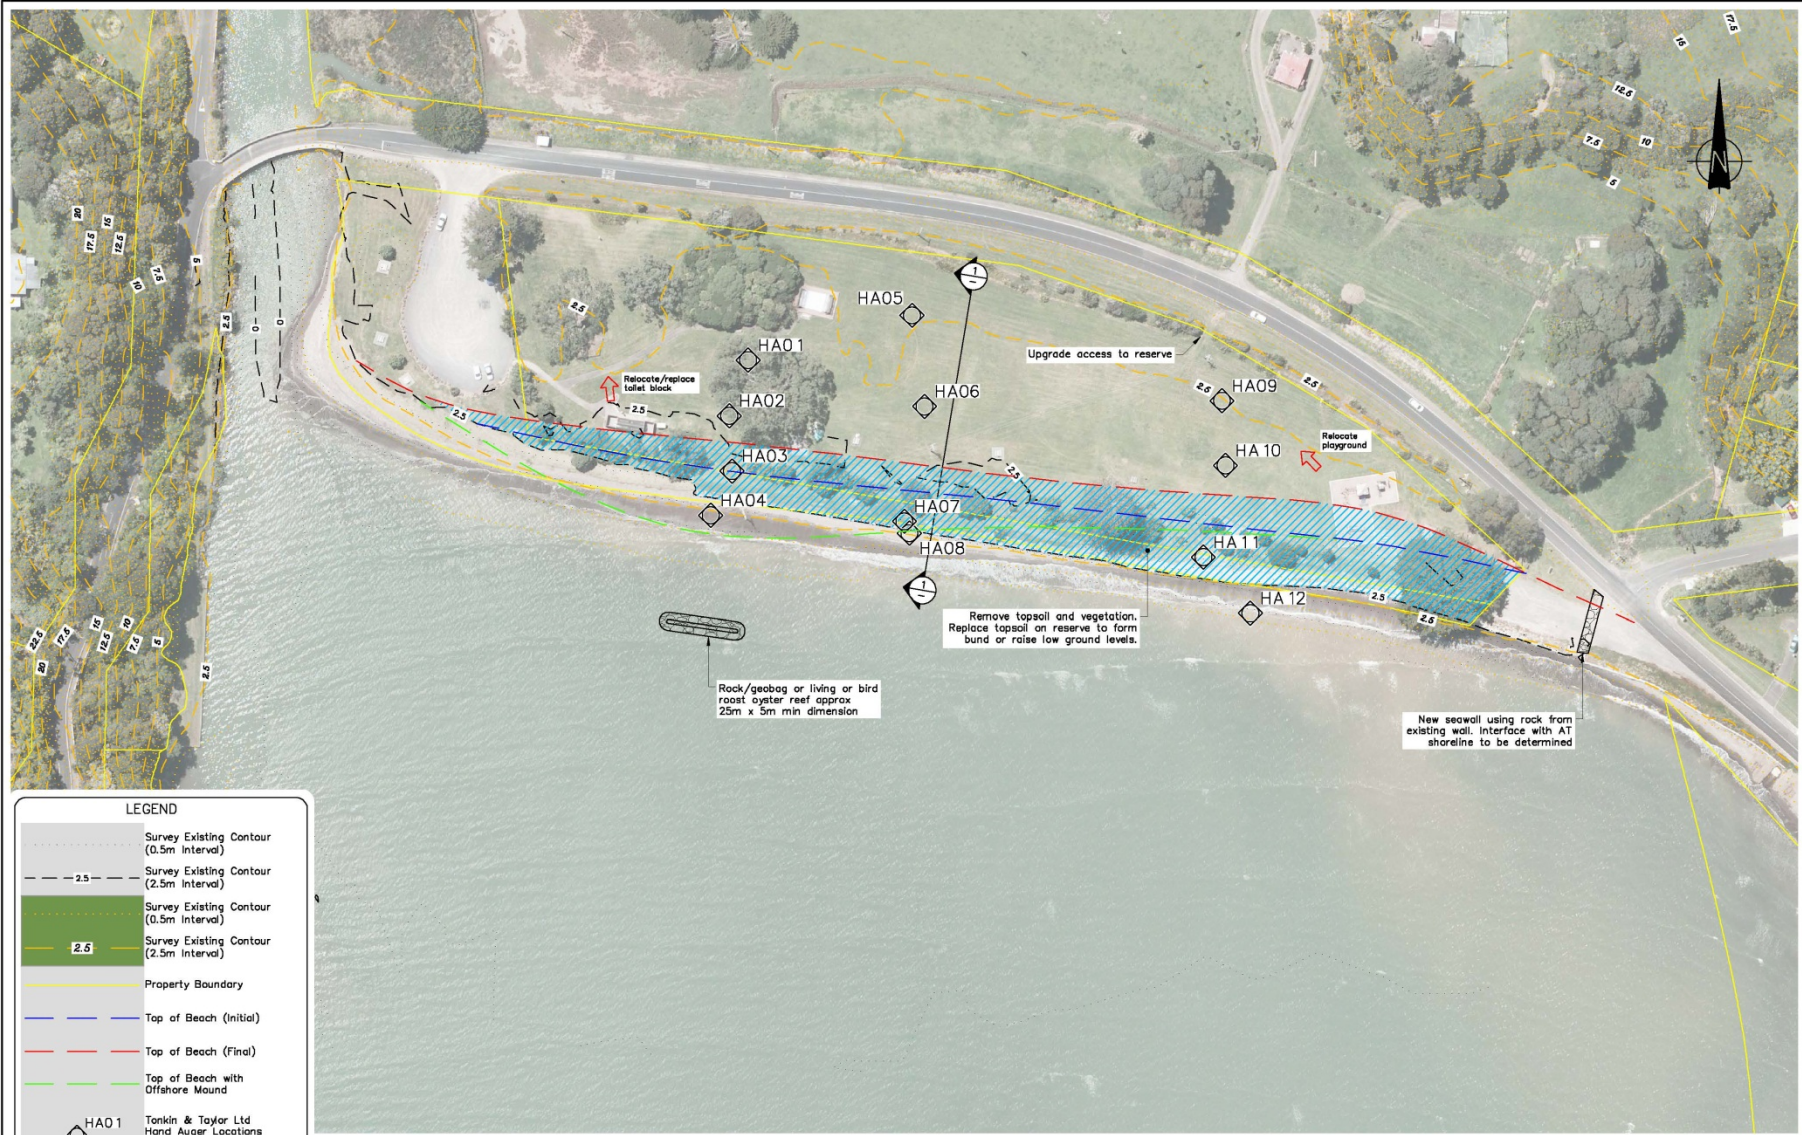
Figure 1

Site Plan Showing Likely Shoreline Positions

**A. Comprehensive Option:** Removal of existing infrastructure (seawall) and manual reconfiguration of reserve (earthworks) to ensure all infrastructure landward of expected shoreline readjustment.

- Includes removal of toilet block and some trees, with relocation of eastern playground.
- 15 – 25m set back (loss of ~4,000m<sup>2</sup> of grass reserve)
- Refer **RED** dashed line

**B. Limited Intervention:** Removal of existing infrastructure (seawall), targeted reconfiguration of reserve (earthworks) and provision of offshore structure to provide limited protection to toilet block.

- Includes removal of some trees and relocation of eastern playground.
- Loss of ~1,500m<sup>2</sup> of grass reserve
- Refer **GREEN** dashed line

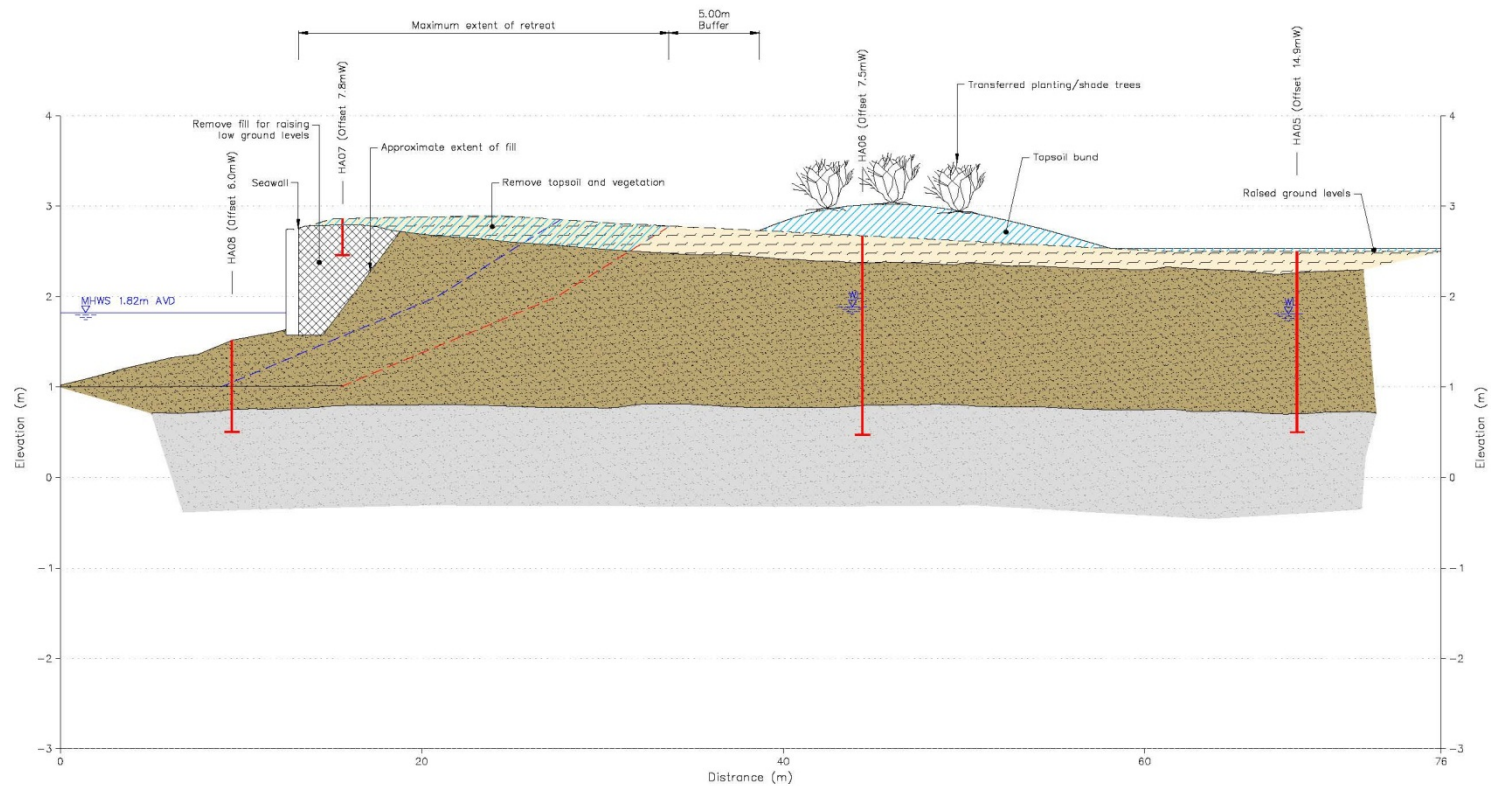
FIG. No. Figure 2

SECTION 1  
SCALE 1:250 (H)  
1:50 (V)

**AUCKLAND COUNCIL**  
HUIA DOMAIN MANAGED REALIGNMENT  
Geology & Typical Section
